DALAIN YINGYU CO., LIMITED 2517 No.692 ZhongShan Road, Dalian, China TEL:86-411-82821900 http://www.dlyingyu.com

SEALING PRODUCTS FOR MAIN SHAFT

BEARING OF WIND TURBINE

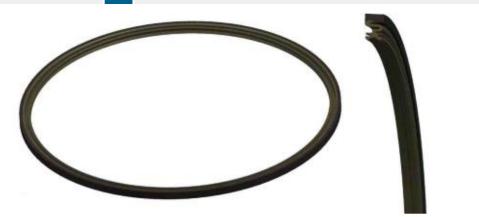
The diagram of TJY sealing ring radial vibration compensation to the shaft

Typical advantage of TJY oil seal is that when the main shaft is in radial vibration, the oil seal can keep well followed. The design of "S" style waist and double sealing lip can quickly

compensate the offset and pressure for the contact interface which can prevent the leakage.

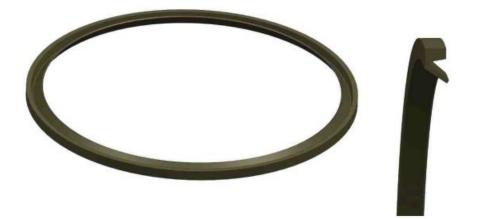
V Ring adopts the design of wearresisting sealing lip to achieve efficient axial sealing.

V Ring is usually used for sealing the lubricating grease of bearings. Generally, it is pressed on the shaft surface by stretching tension to have the effect of static sealing and fixture. With good adaptability it can compensate a larger tolerance and angular deviation. There is no high requirement for the surface finish and hardness of shaft, it can protect against dust, impurities, water and other medium.

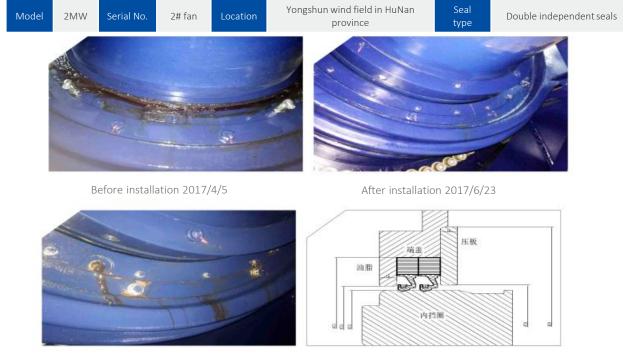
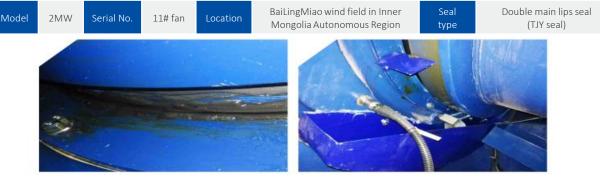
After installation 2017/8/14

Install diagram

Before installation 2016/6/21

After installation 2017/5/23

After installation 2018/9/18

Seal type Main-vice lips seal (TJRF seal)
